Overcoming DAB+ SFN Network Challenges

Here's what we learned when trialing small-scale, local digital terrestrial services in Poland

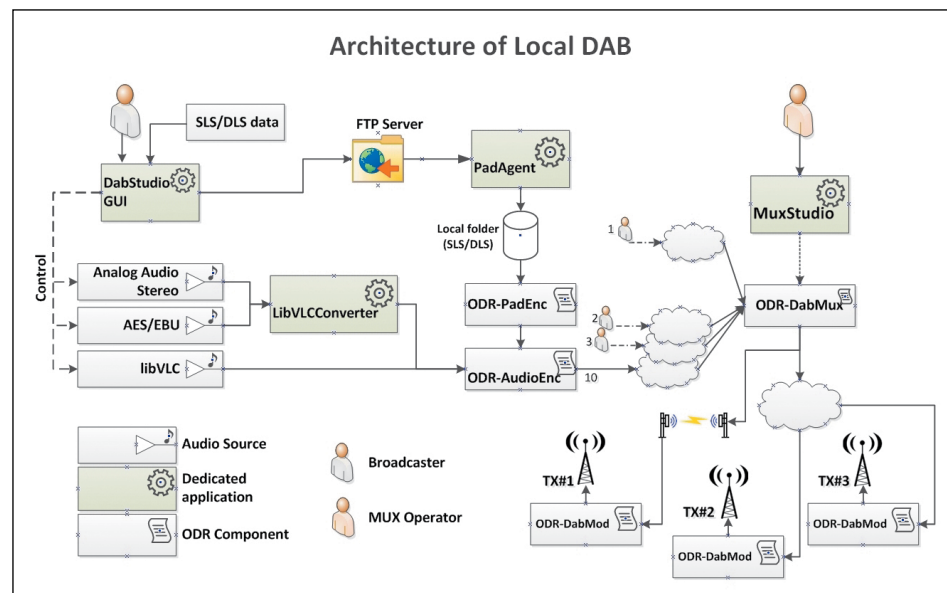
Fig. 1: The architecture of the local DAB project in Wrocław, Poland.

At first, we thought the problem was due to signal distribution because the network uses a regular internet connection as the main link between all 10 radio stations and the local DAB multiplexer located at the university, as well as between the multiplexer and two of the three transmitters. A microwave link in the 5 GHz band feeds the third

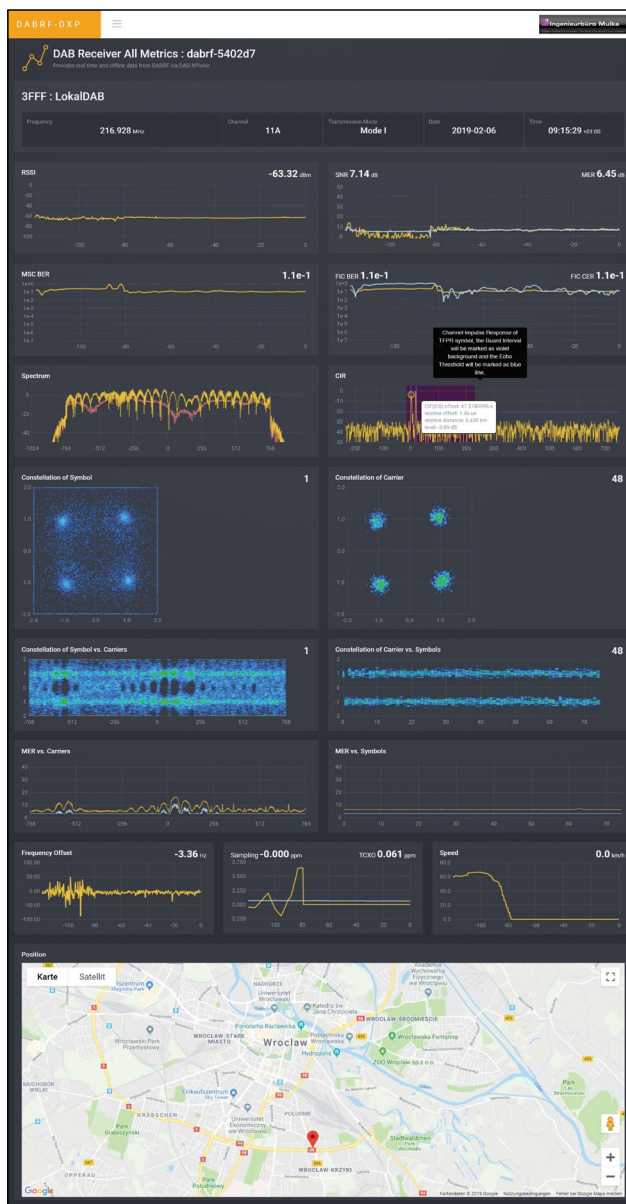
We replayed the recorded EDI file in the laboratory and analyzed the metrics. An interesting point is the low SNR at good RF levels at some critical places. Figs. 3 and 4 illustrate the findings.

In both cases, the RF level is around -62 dBm, which is high enough for a good reception, but the SNR is 8 dB, which is very low. The reason is that Transmitter Three had an unexpected delay of around
(continued on page 6)

Fig. 3: The results of the DAB signal monitoring tests. DABRF received and recorded the signal from transmitter numbers one and two for analyzation in the lab.

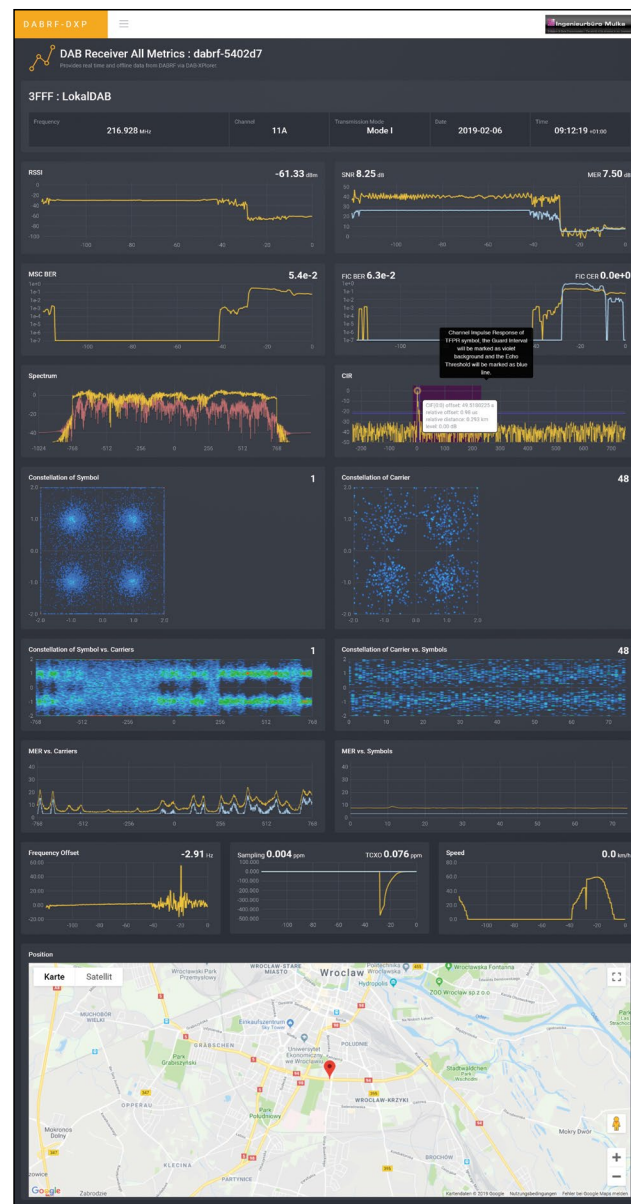
Fig. 4: The results of the DAB signal monitoring tests. DABRF received and recorded the signal from transmitter number three for analysis in the lab.

We discovered that the problem was caused by the wrong address on the DNS server in Transmitter Three, which in turn caused a problem with the transmission of the corresponding NTP data, resulting in the lack of synchronization.

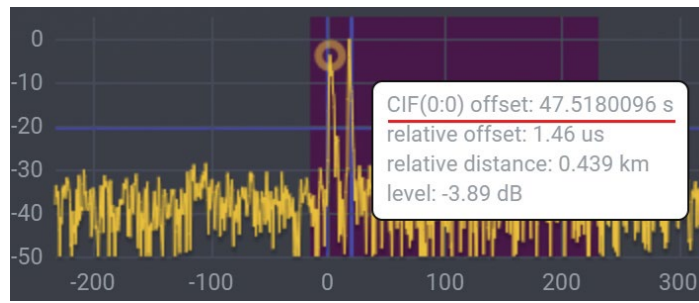
2 seconds, which was measured by the DABRF in the diagram of the channel impulse response (Figs. 5 and 6).

Fig. 5: The results of the DAB signal monitoring tests. Near Transmitter Two: CIF(0:0) offset = 47,518 s

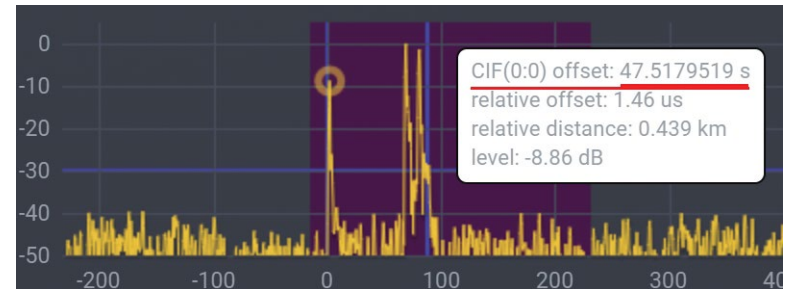
CIF (0:0) offset is now the same for all three transmitters. This is visible in Fig. 9, which illustrates the channel impulse response where all three transmit-

ters, seen as three yellow peaks, work within the guard interval of 246 μs represented with a violet background.

Fig. 9: A graph showing the same offset for all three transmitters.

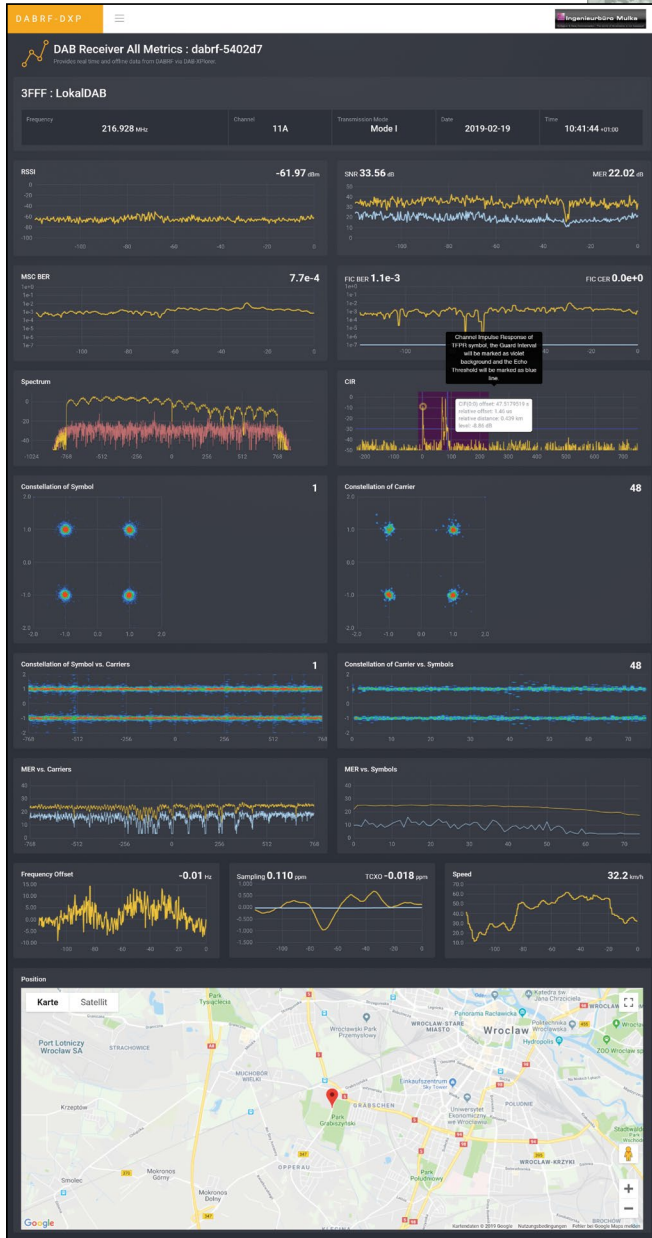
Now, the RF level is at about the same level as before (-62 dB), but SNR is higher than 33 dB and that ensures perfect reception.

Fig. 8: Results after time synchronization correction.

After correcting the time synchronization of transmitter number three, the SFN works as expected. Figs. 7 and 8 show the result.
